EQUINOX RESOURCES (WASH.) INC.
VAN STONE MINE, WASHINGTON STATE, USA

RECLAMATION AND CLOSURE PLAN

Prepared by
Beacon Hill Consultants (1988) Ltd.
908 - 1100 Melville Street
Vancouver, B.C. V6E 4A6

July, 1999

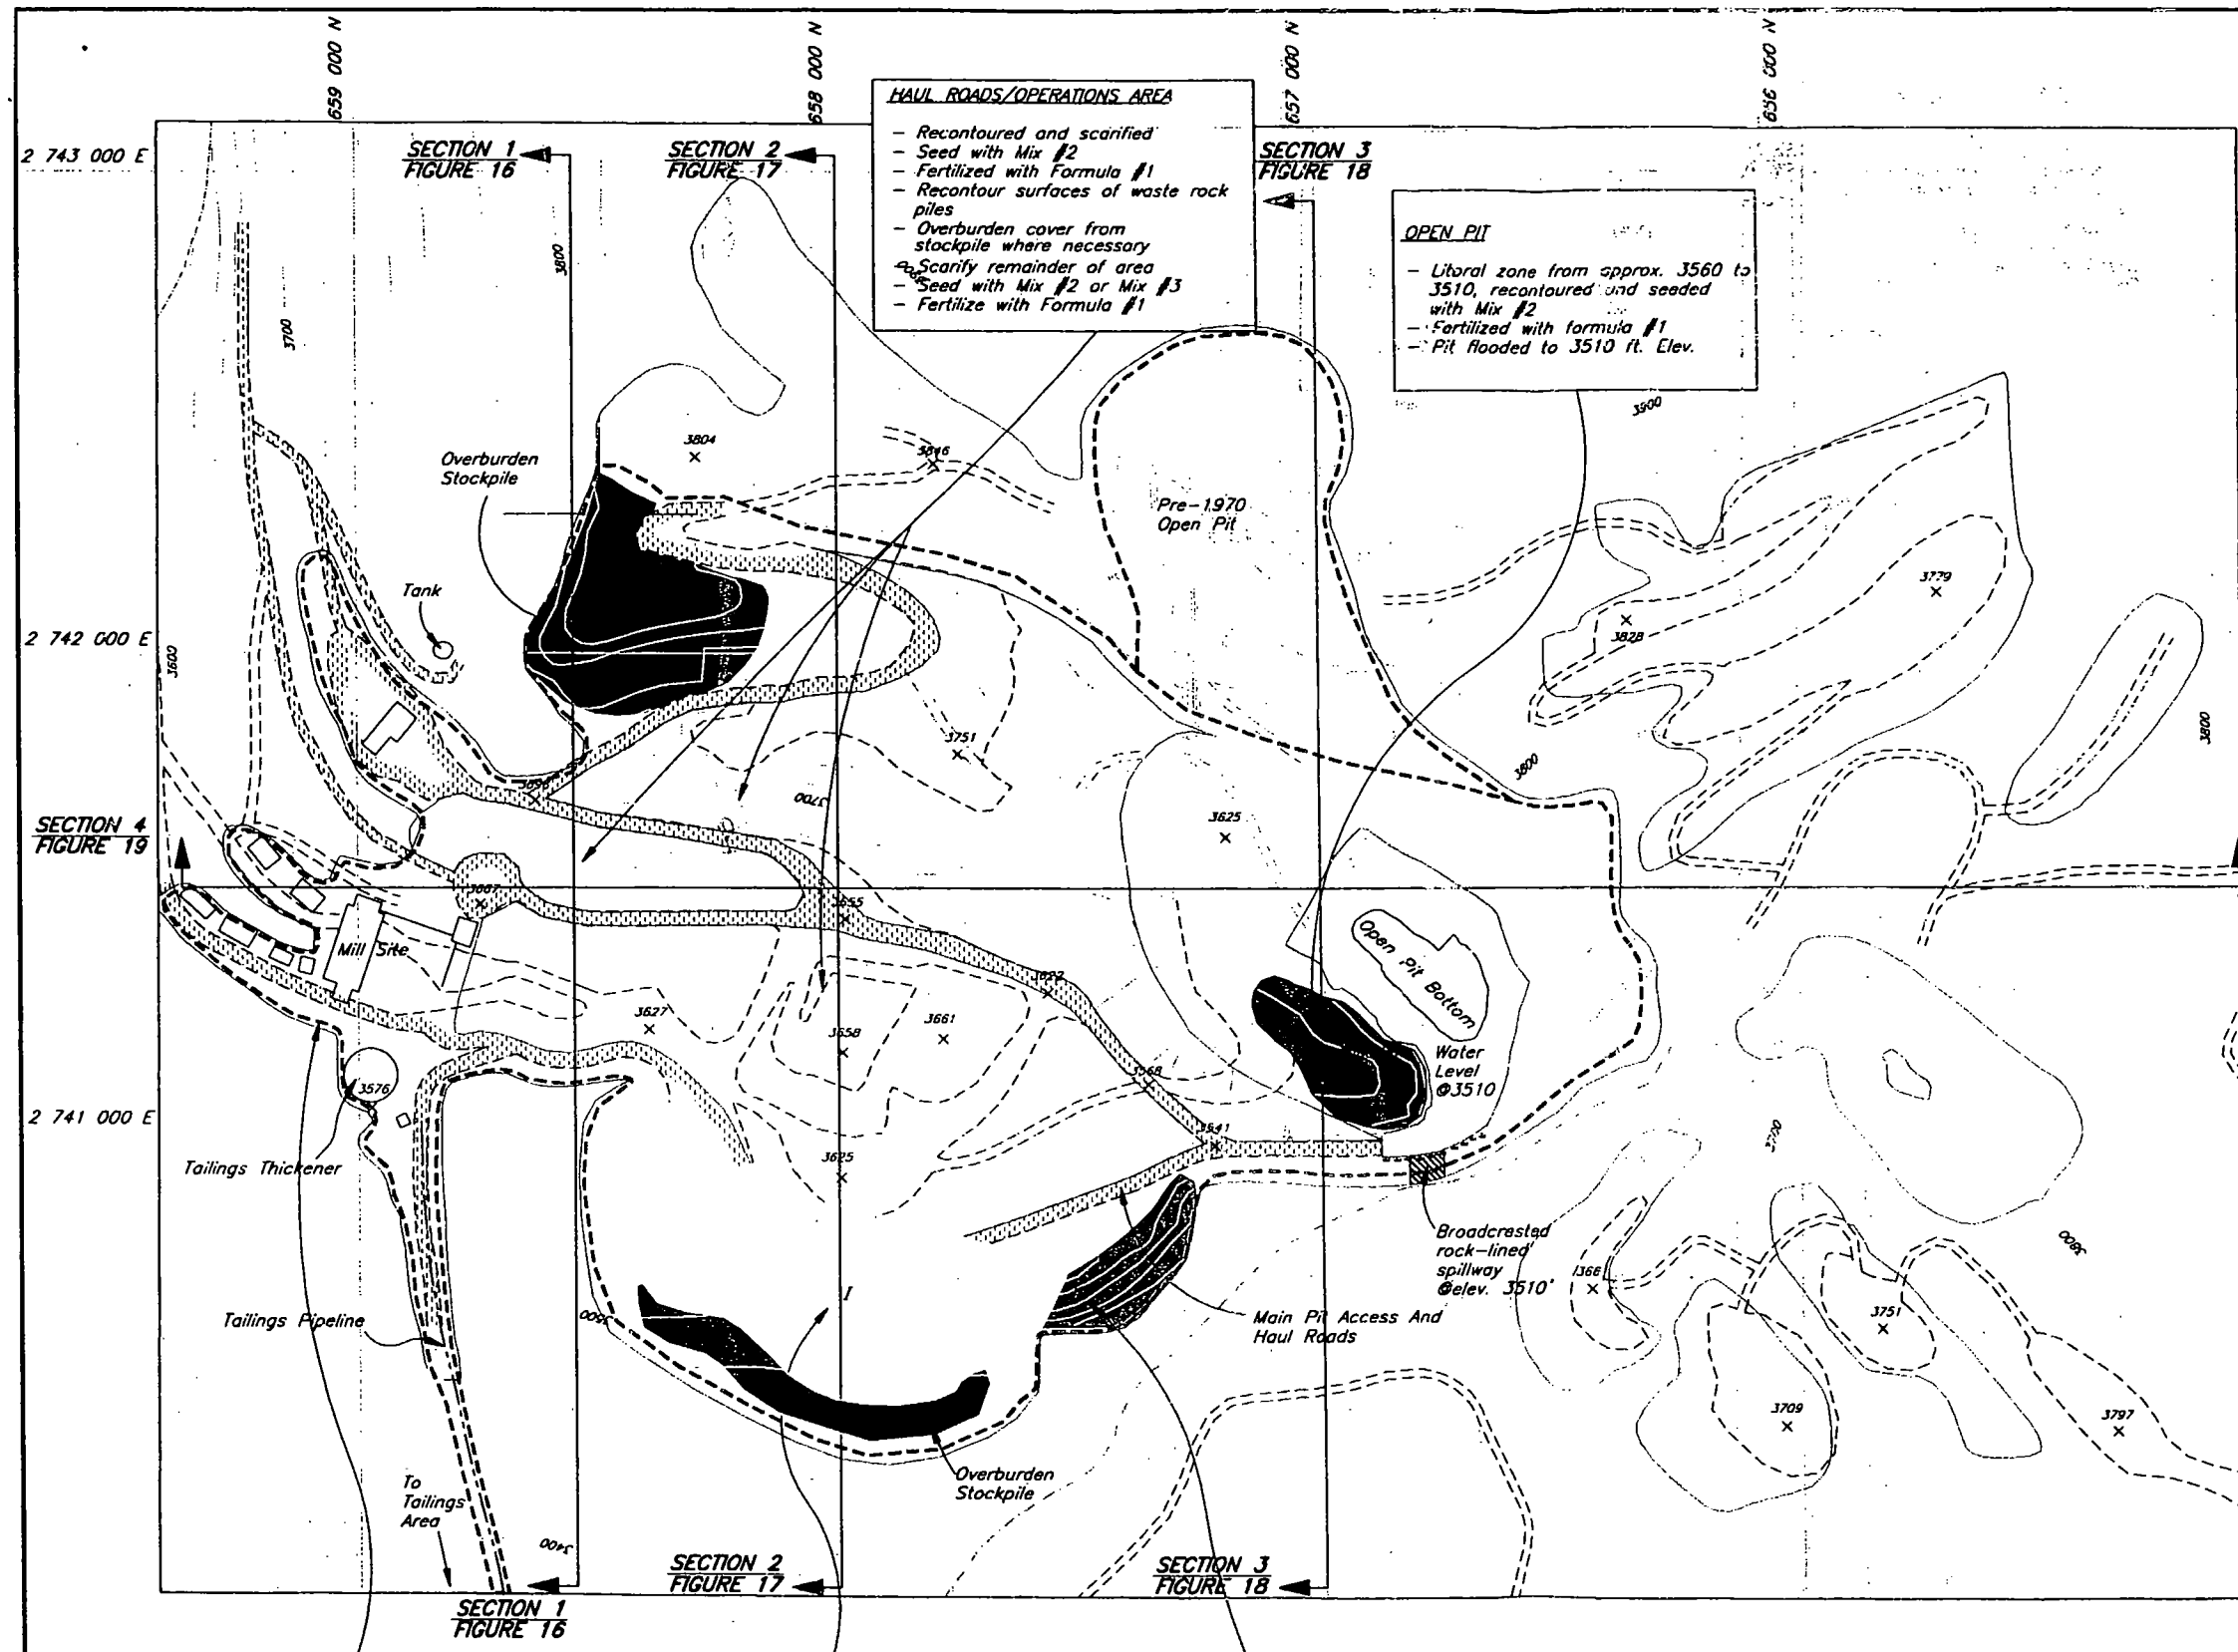
- HAUL ROADS/OPERATIONS AREA**
- Recontoured and scarified
 - Seed with Mix #2
 - Fertilized with Formula #1
 - Recontour surfaces of waste rock piles
 - Overburden cover from stockpile where necessary
 - Scarify remainder of area
 - Seed with Mix #2 or Mix #3
 - Fertilize with Formula #1

- OPEN PIT**
- Lateral zone from approx. 3560 to 3510, recontoured and seeded with Mix #2
 - Fertilized with formula #1
 - Pit floored to 3510 ft. Elev.

- MILL AND ANCILLARY FACILITIES**
- Equipment removed
 - Hazardous wastes removed
 - Site recontoured and scarified
 - Seeded with Mix #2 and fertilized with Formula #1
 - Planted with seedlings mix deciduous and coniferous

- WASTE ROCK STORAGE AREA-SECTION II**
- Remains in current condition as a talus slope

The mill and ancillary facilities includes the process plant, crushing plant, conveyor system, reagent and fuel storage areas, tailings thickener, and temporary ore stockpiles. A complete set of reclamation plans together with post-closure cross-sections are presented in Figures 14 through 31 for each of the two closure scenarios. These are followed with site revegetation plans in Figures 32 through 35 at the end of this report. A preliminary schedule which is linked to a re-opening decision is presented in Table 3.

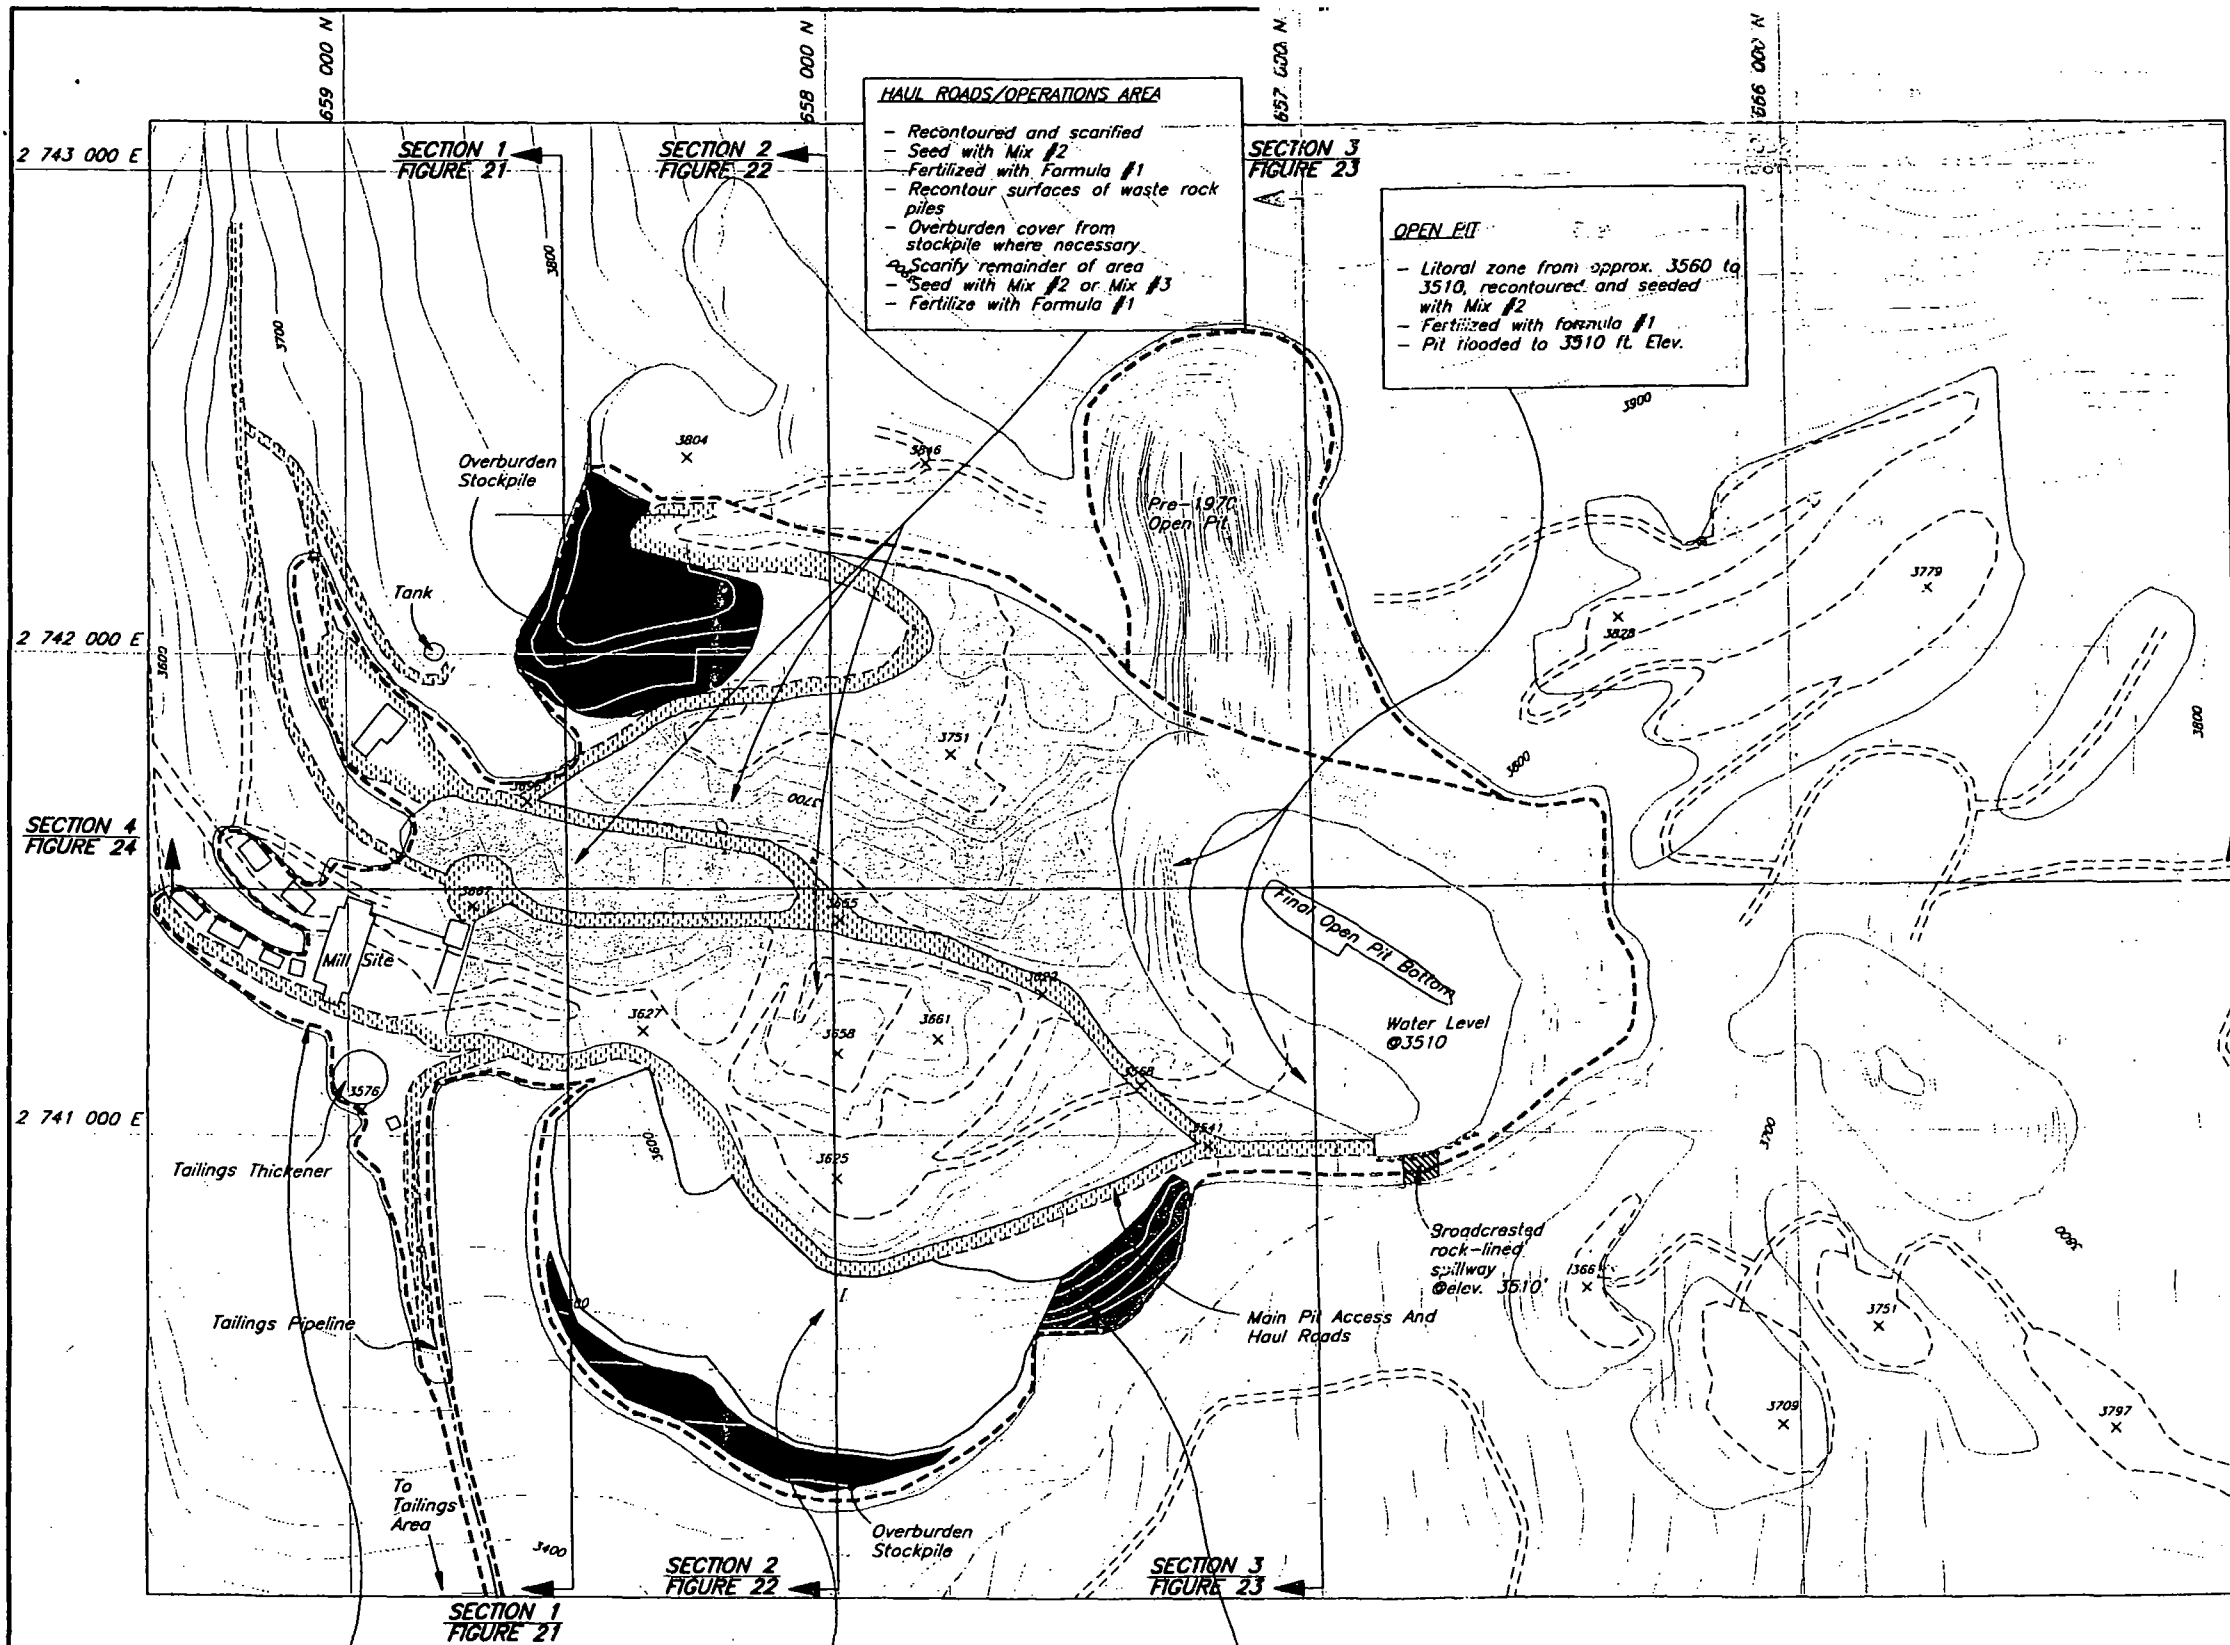
HALLAM KNIGHT PIESOLD LTD. ENVIRONMENTAL CONSULTANTS-VANCOUVER, B.C.		EQUINOX RESOURCES (WASHINGTON) INC.	
		VAN STONE MINE-OPEN PIT	
		CLOSURE OF RE-OPENED OPERATIONS FIGURE 20	
DESIGNED	BH		
DRAWN	AW		
CHECKED	BH		
APPROVED			
DATE	JUNE 2, 1999	SCALE AS SHOWN	DRG. NO. H3172
		REV.	0

- HAUL ROADS/OPERATIONS AREA**
- Recontoured and scarified
 - Seed with Mix #2
 - Fertilized with Formula #1
 - Recontour surfaces of waste rock piles
 - Overburden cover from stockpile where necessary
 - Scarify remainder of area
 - Seed with Mix #2 or Mix #3
 - Fertilize with Formula #1

- OPEN PIT**
- Littoral zone from approx. 3560 to 3510, recontoured and seeded with Mix #2
 - Fertilized with formula #1
 - Pit flooded to 3510 ft. Elev.

- MILL AND ANCILLARY FACILITIES**
- Equipment removed
 - Hazardous wastes removed
 - Site recontoured and scarified
 - Seeded with Mix #2 and fertilized with Formula #1
 - Planted with seedlings mix deciduous and coniferous

- WASTE ROCK STORAGE AREA-SECTION II**
- Remains in current condition as a talus slope

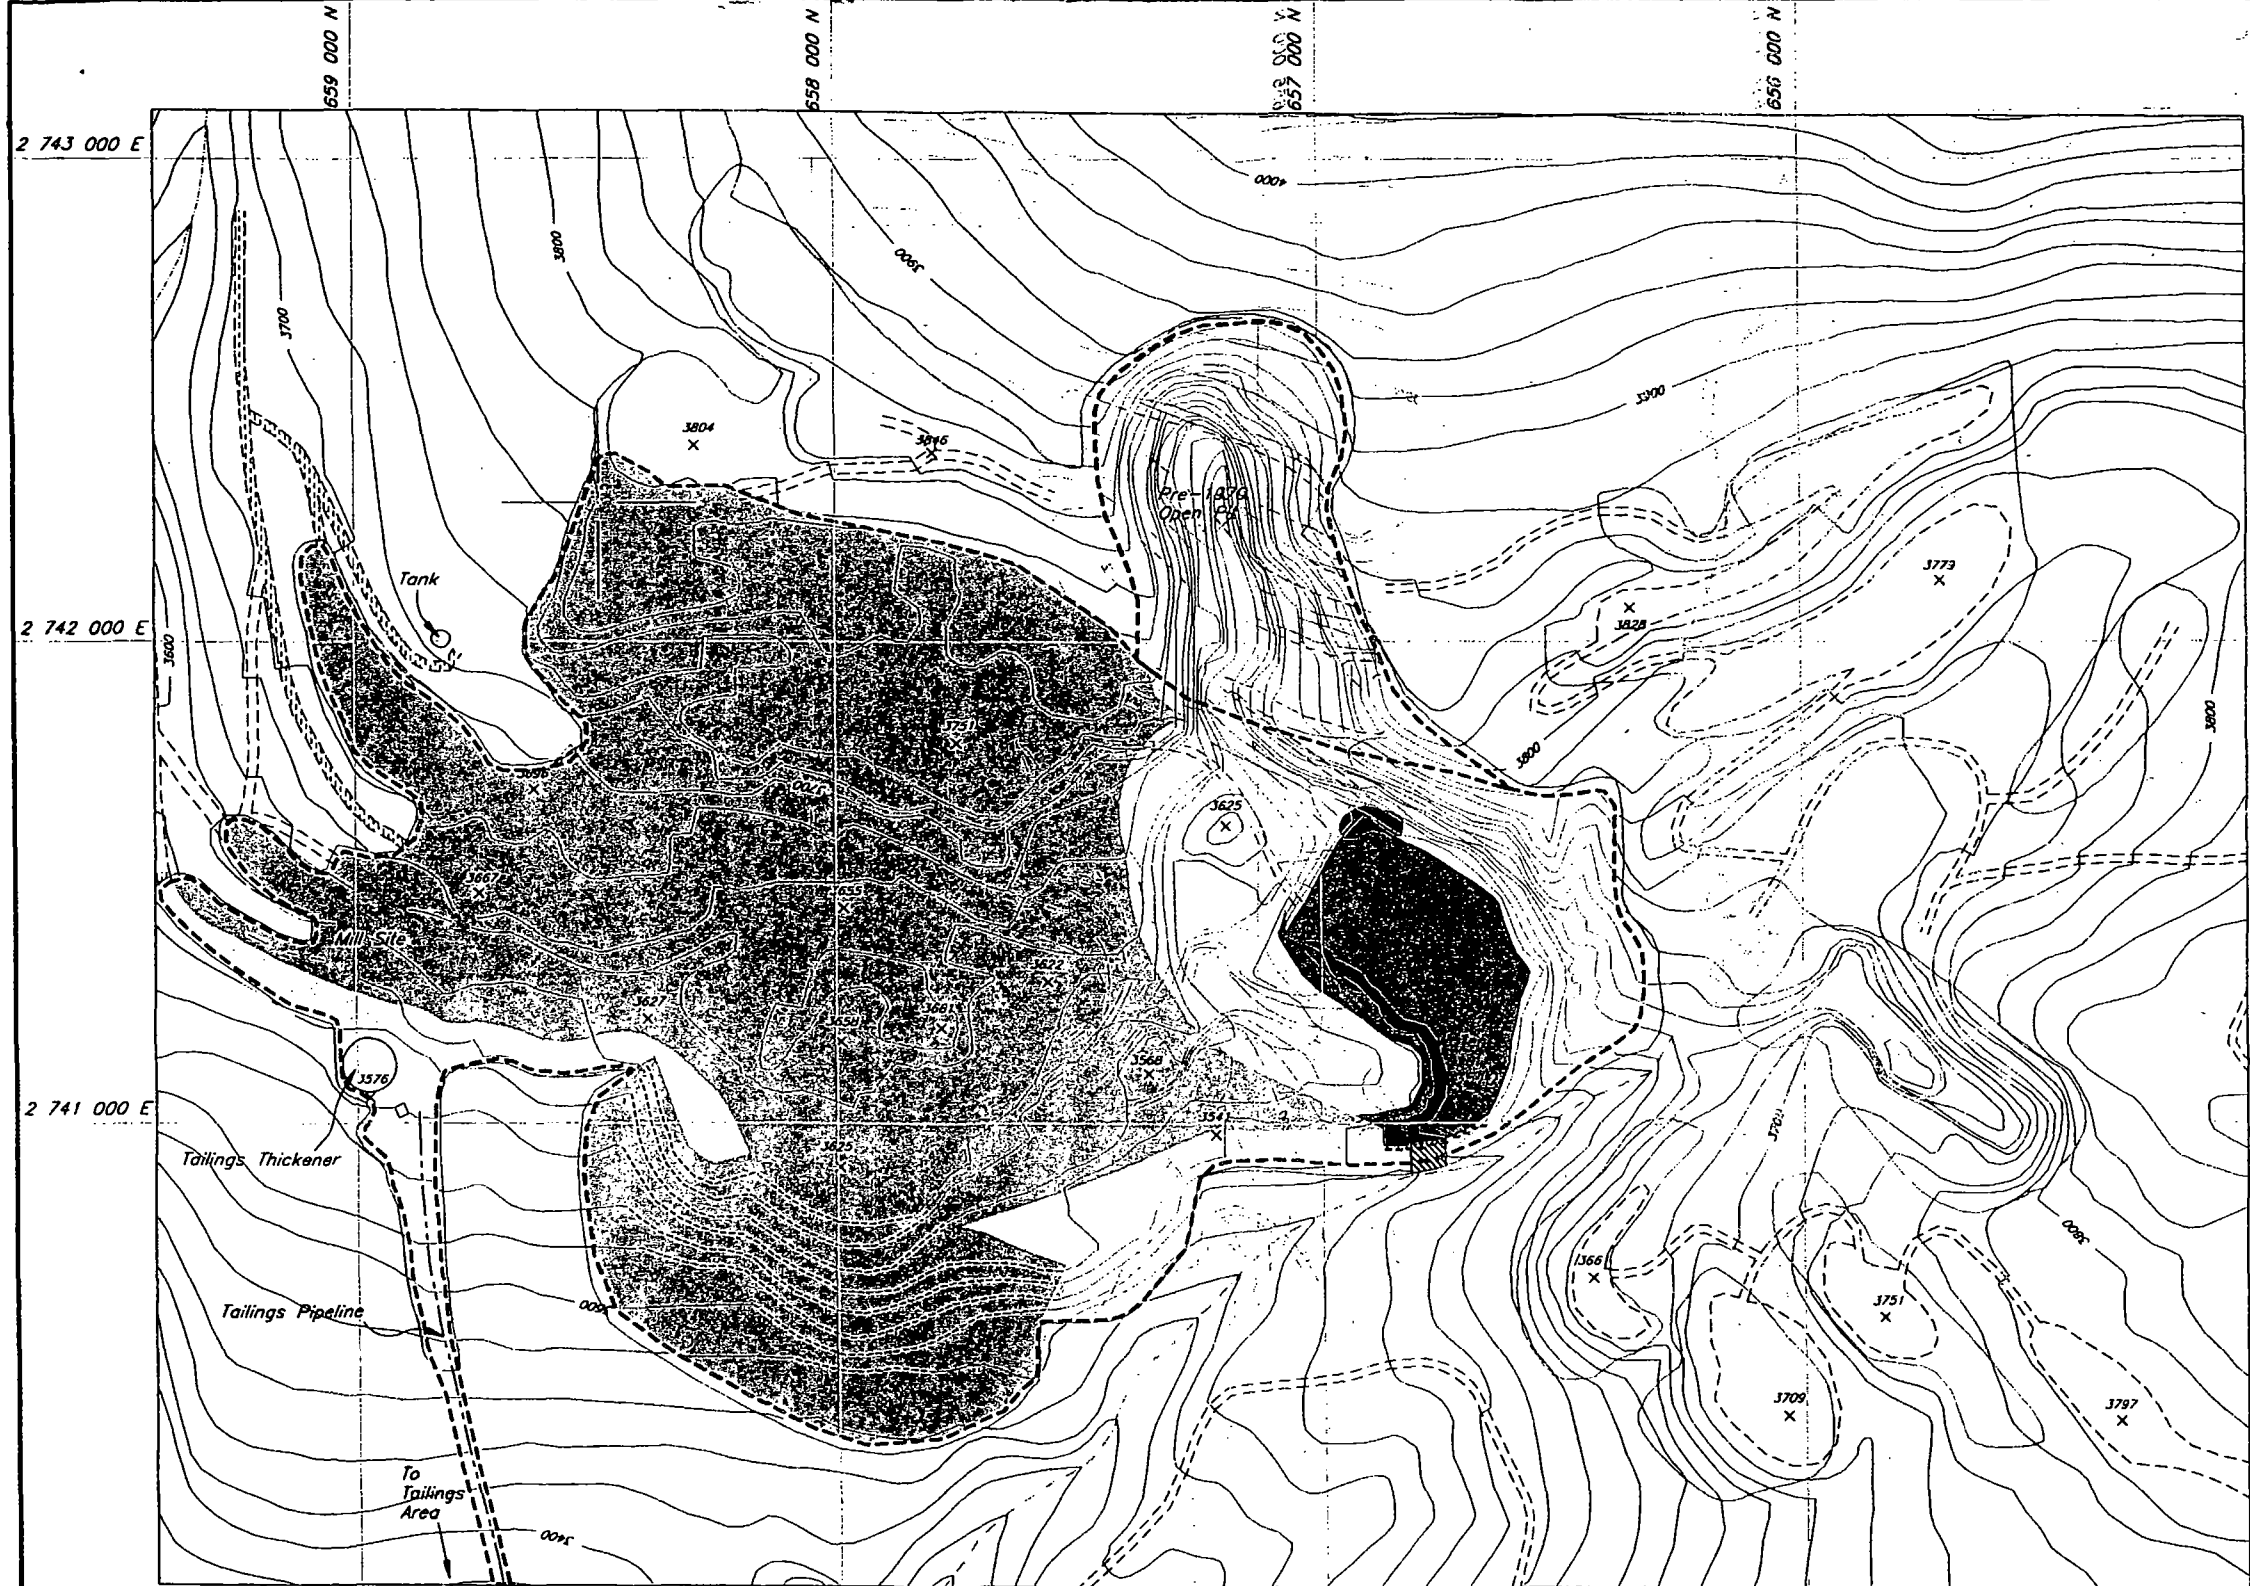
HALLAM KNIGHT PIESOLD LTD. ENVIRONMENTAL CONSULTANTS-VANCOUVER, B.C.		EQUINOX RESOURCES (WASHINGTON) INC.	
	DESIGNED	BH	VAN STONE MINE-OPEN PIT
	DRAWN	AW	
	CHECKED	BH	
	APPROVED		
		REVEGETATION PLAN OF EXISTING MINE SITE FIGURE 32	
DATE	JUNE 2, 1999	SCALE AS SHOWN	DRG. NO. H3172
		REV.	0

TYPES OF VEGETATIONS

Until experimental test plots indicate better results from indigenous species, recommended seed mixes as presented in Table 1. These may be varied on the basis of research trials, discussions with regulatory agencies, commercial suppliers, and experience from similar environments. Application rates of 40 lb/acre are recommended, and some areas may require repeated seeding.

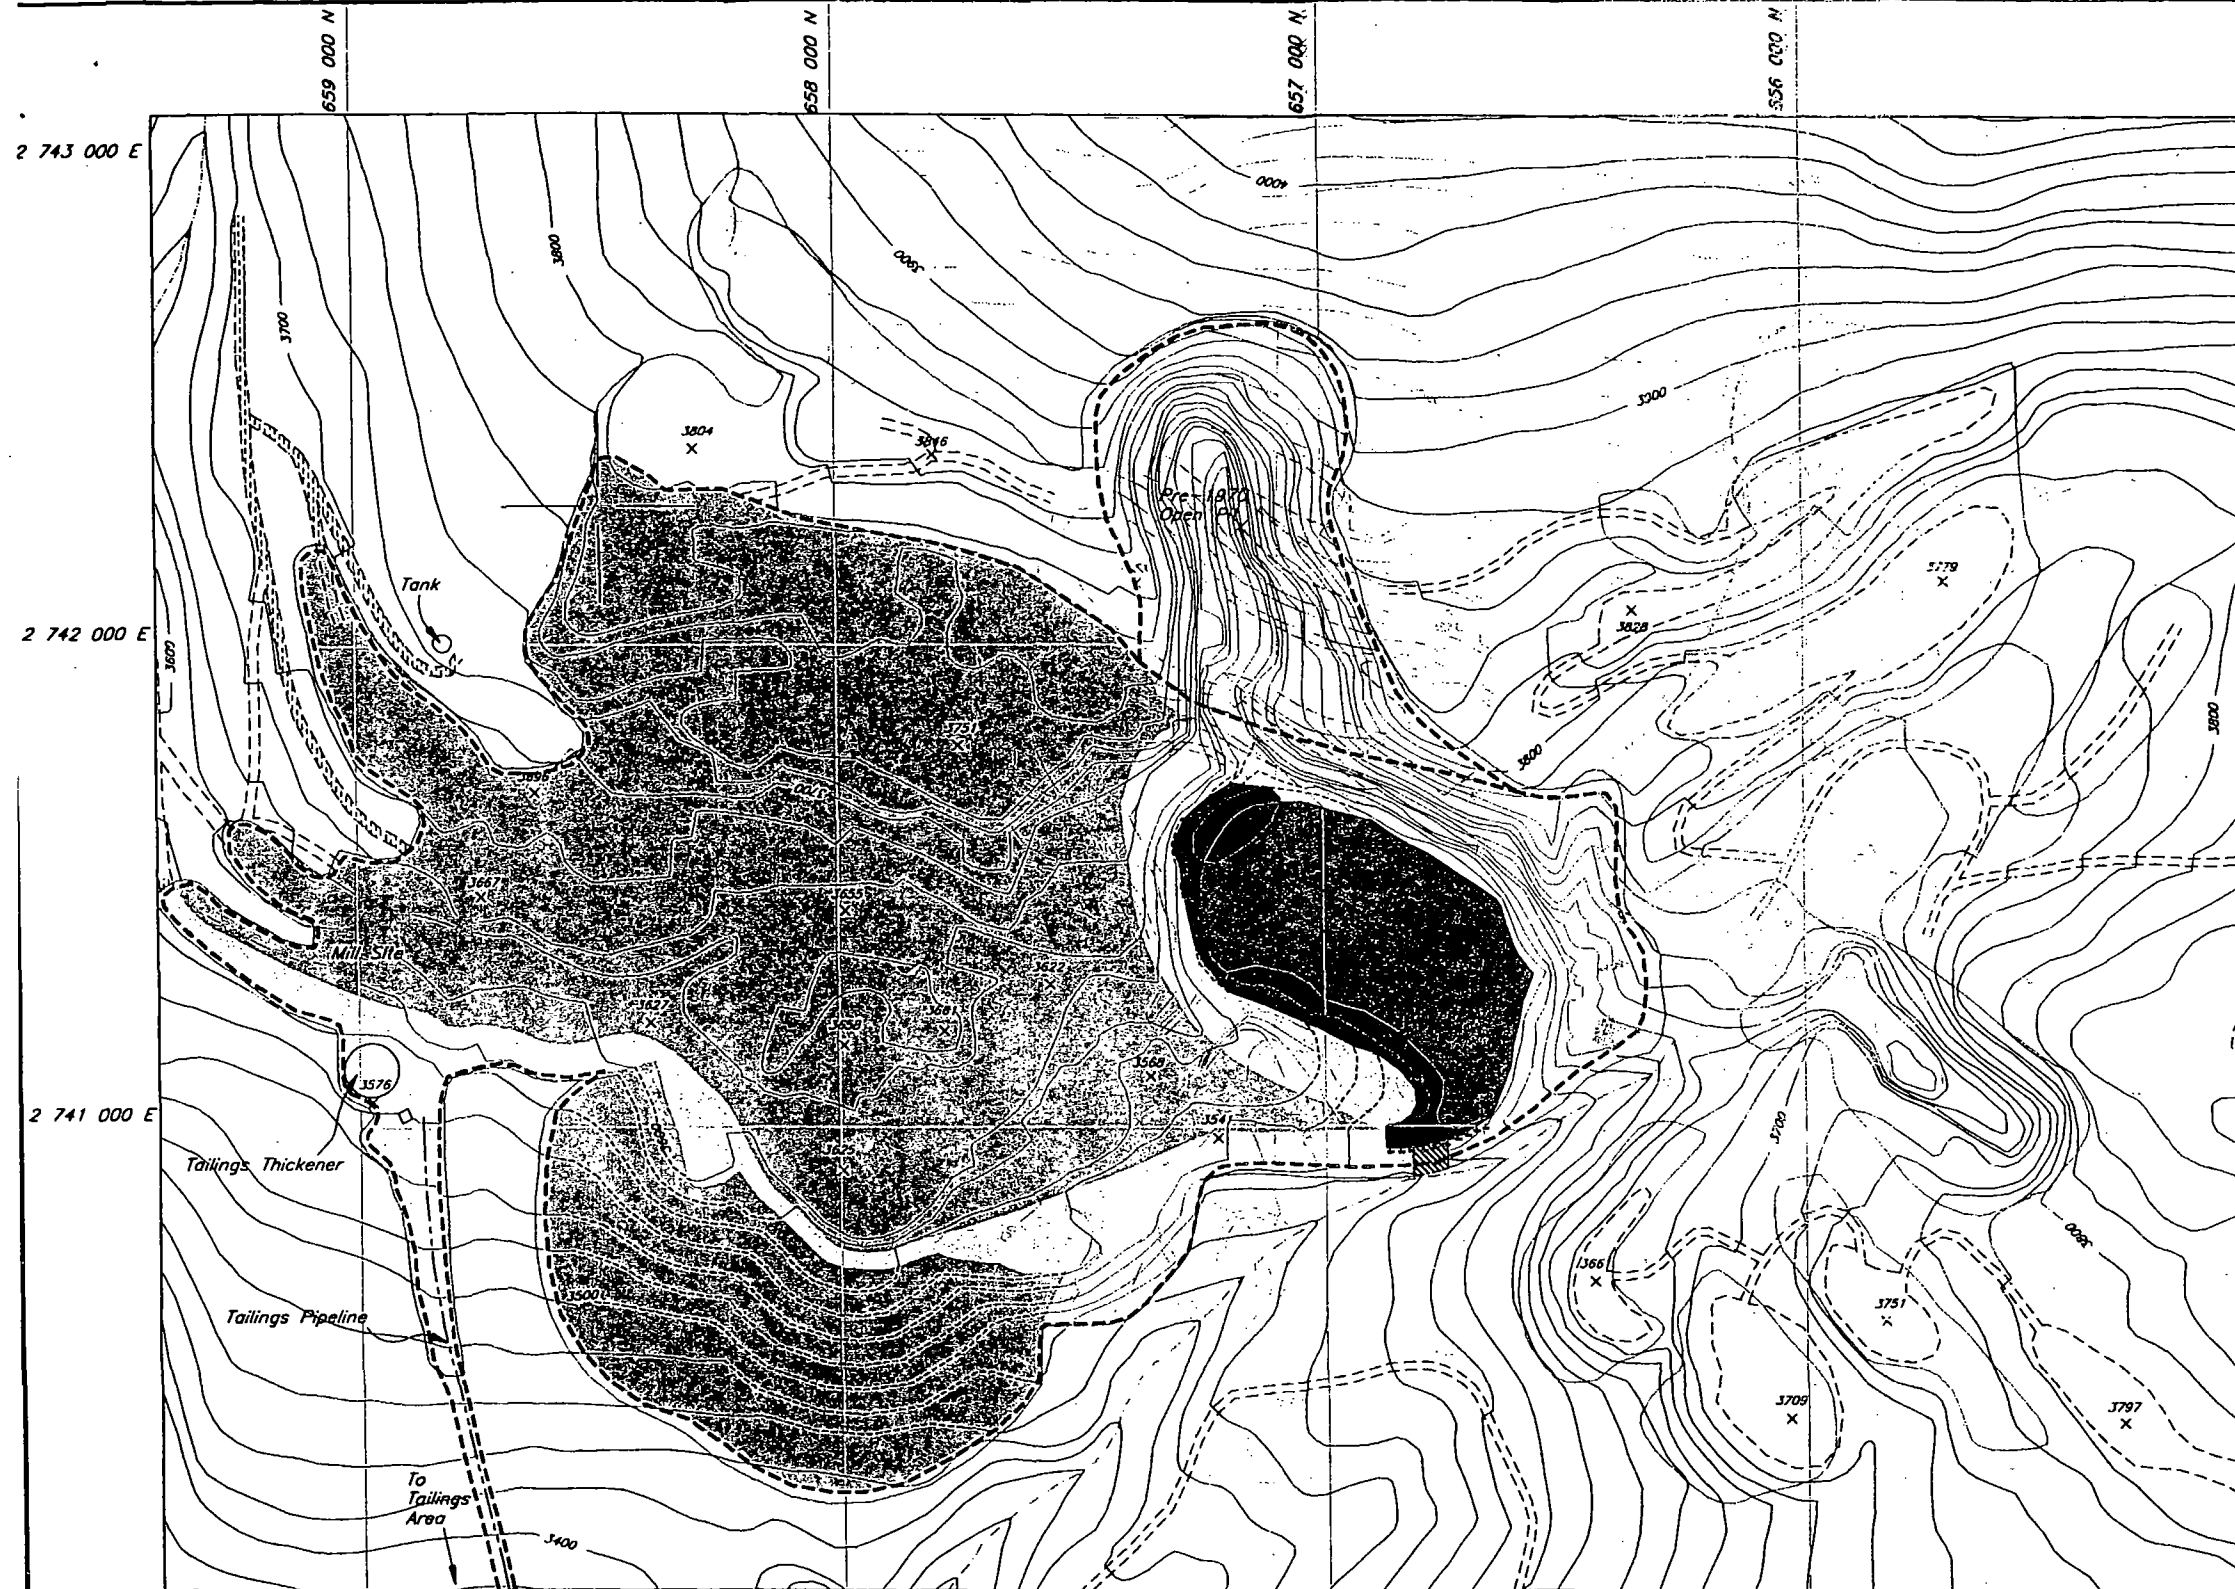
HALLAM KNIGHT PIESOLD LTD. ENVIRONMENTAL CONSULTANTS-VANCOUVER, B.C.		EQUINOX RESOURCES (WASHINGTON) INC.	
	DESIGNED	BH	VAN STONE MINE-OPEN PIT REVEGETATION PLAN OF RE-OPENED OPERATIONS FIGURE 33
	DRAWN	AW	
	CHECKED	BH	
	APPROVED		
DATE	JUNE 2, 1999	SCALE AS SHOWN	DRG. NO. H3172
		REV. 0

TYPES OF VEGETATION
